Evaluation Report 272

Morris M-600 Air Flow Seeder

A Co-operative Program Between
ALBERTA FARM MACHINERY RESEARCH CENTRE
PAMI
PRAIRIE AGRICULTURAL MACHINERY INSTITUTE

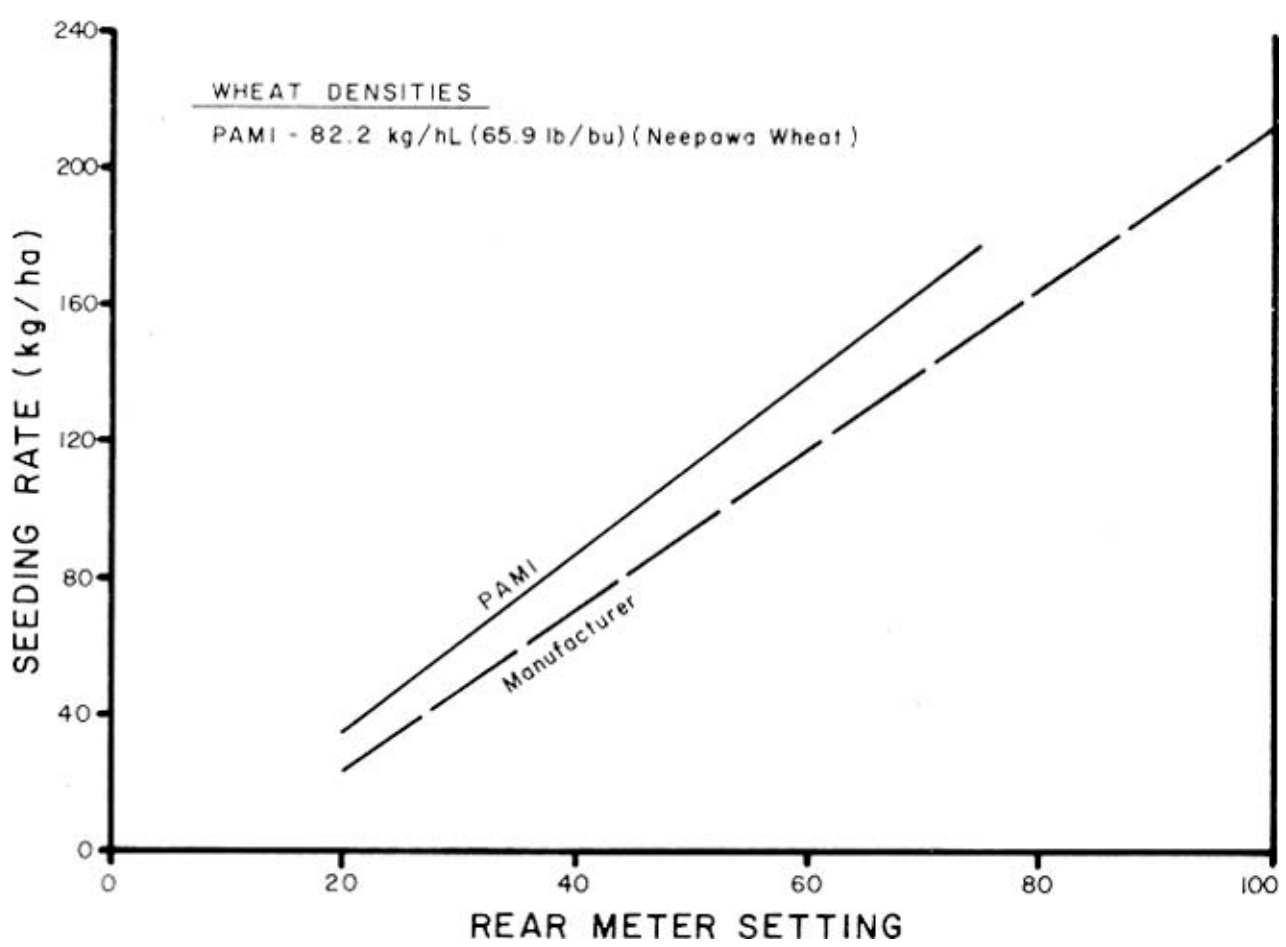
FIGURE 2. Metering Accuracy for the Rear Meter in Wheat.

The manufacturer's metering calibrations were acceptable in barley, oats and fertilizer. The measured calibration was 22% higher than the manufacturer's rate for wheat and was over twice the manufacturer's rate for rapeseed at normal seeding rates.

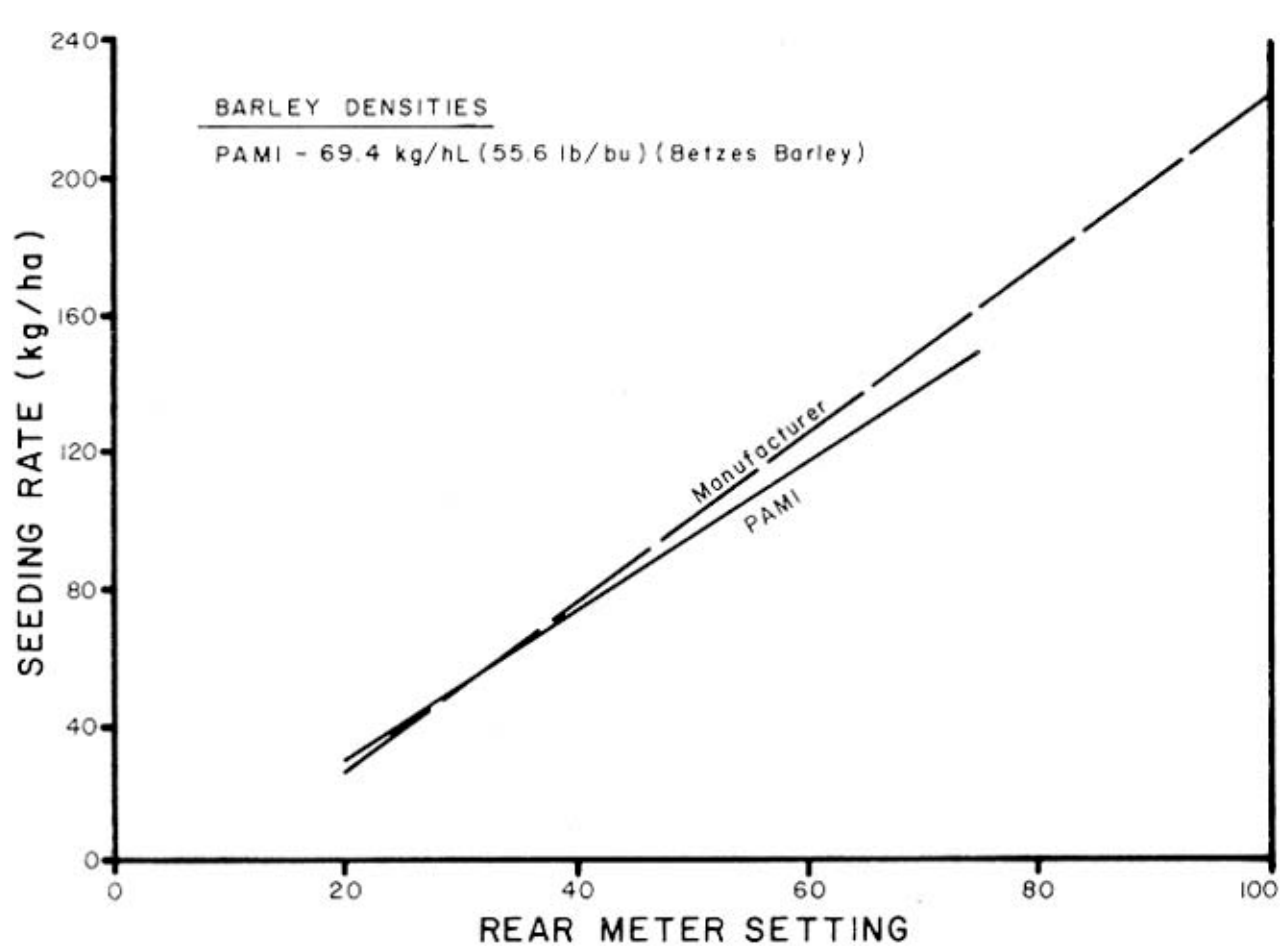
FIGURE 3. Metering Accuracy for the Rear Meter in Barley.

Calibration curves for wheat, barley and oats, using the rear meter, are given in FIGURES 2 to 4. PAMI's calibration curves are compared to the manufacturer's calibration curves. At a seeding rate of 80 kg/ha (70 lb/ac), measured rates were 22% higher than the manufacturer's calibration in wheat, 5% lower in barley, and 12% lower than the manufacturer's rate in oats.

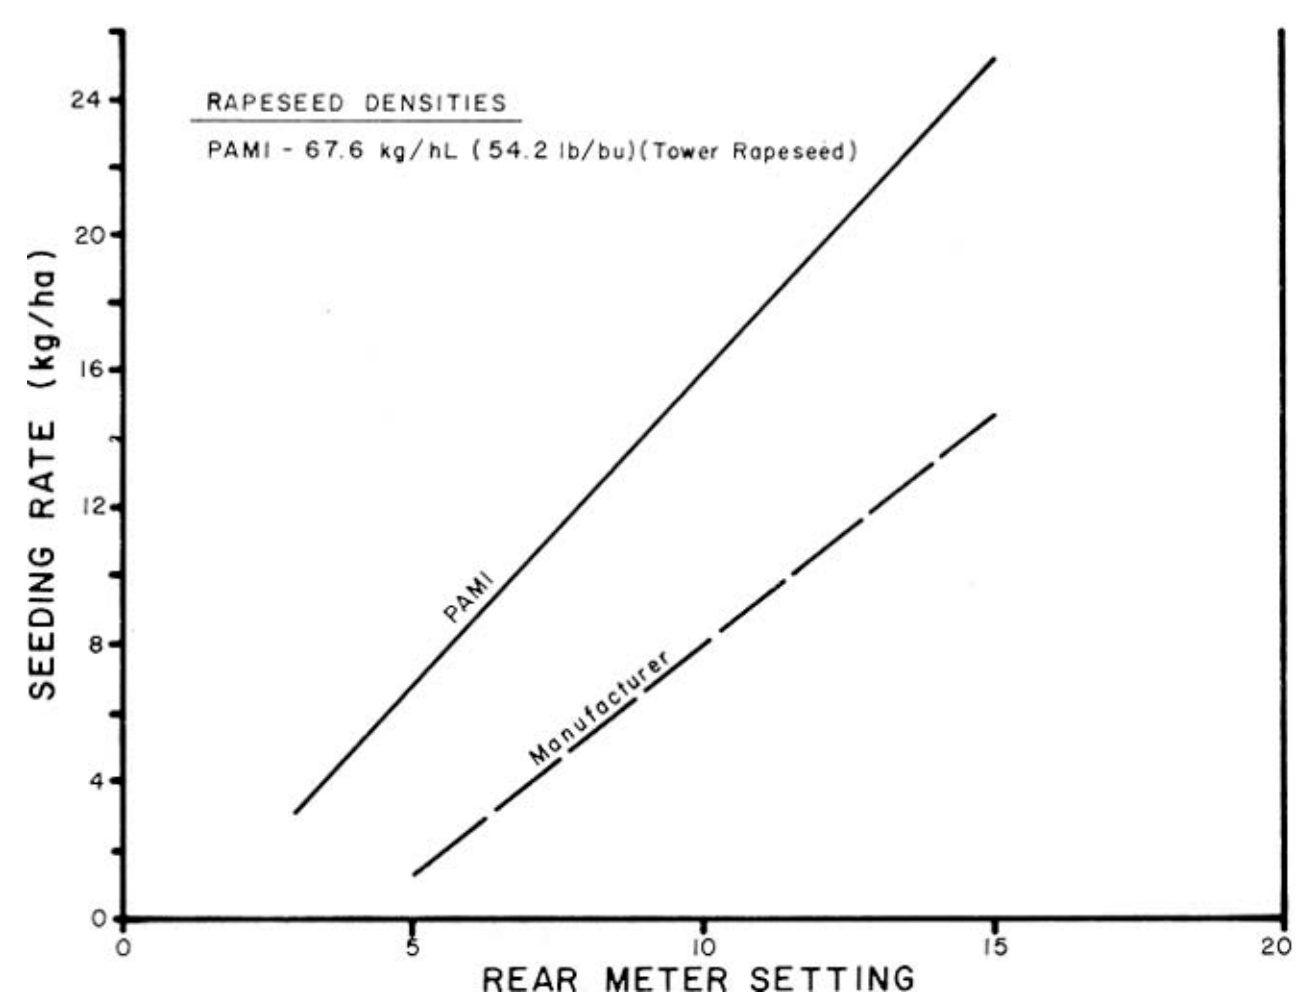
FIGURE 5. Metering Accuracy for the Rear Meter in Rapeseed.

At a seeding rate of 7 kg/ha (6.2 lb/ac) in rapeseed (FIGURE 5), the measured rate was over twice the manufacturer's indicated rate. At a seeding rate of 3 kg/ha (2.7 lb/ac), the measured rate was three times the manufacturer's indicated rate. It is recommended that the manufacturer's calibration for rapeseed be improved.

1. Indicating in the operator's manual the actual seed densities used in preparation of the meter calibration charts.
2. Improving the metering calibration for rapeseed.
3. Modifications to the' distribution system to improve distribution uniformity in fertilizer at high application rates.

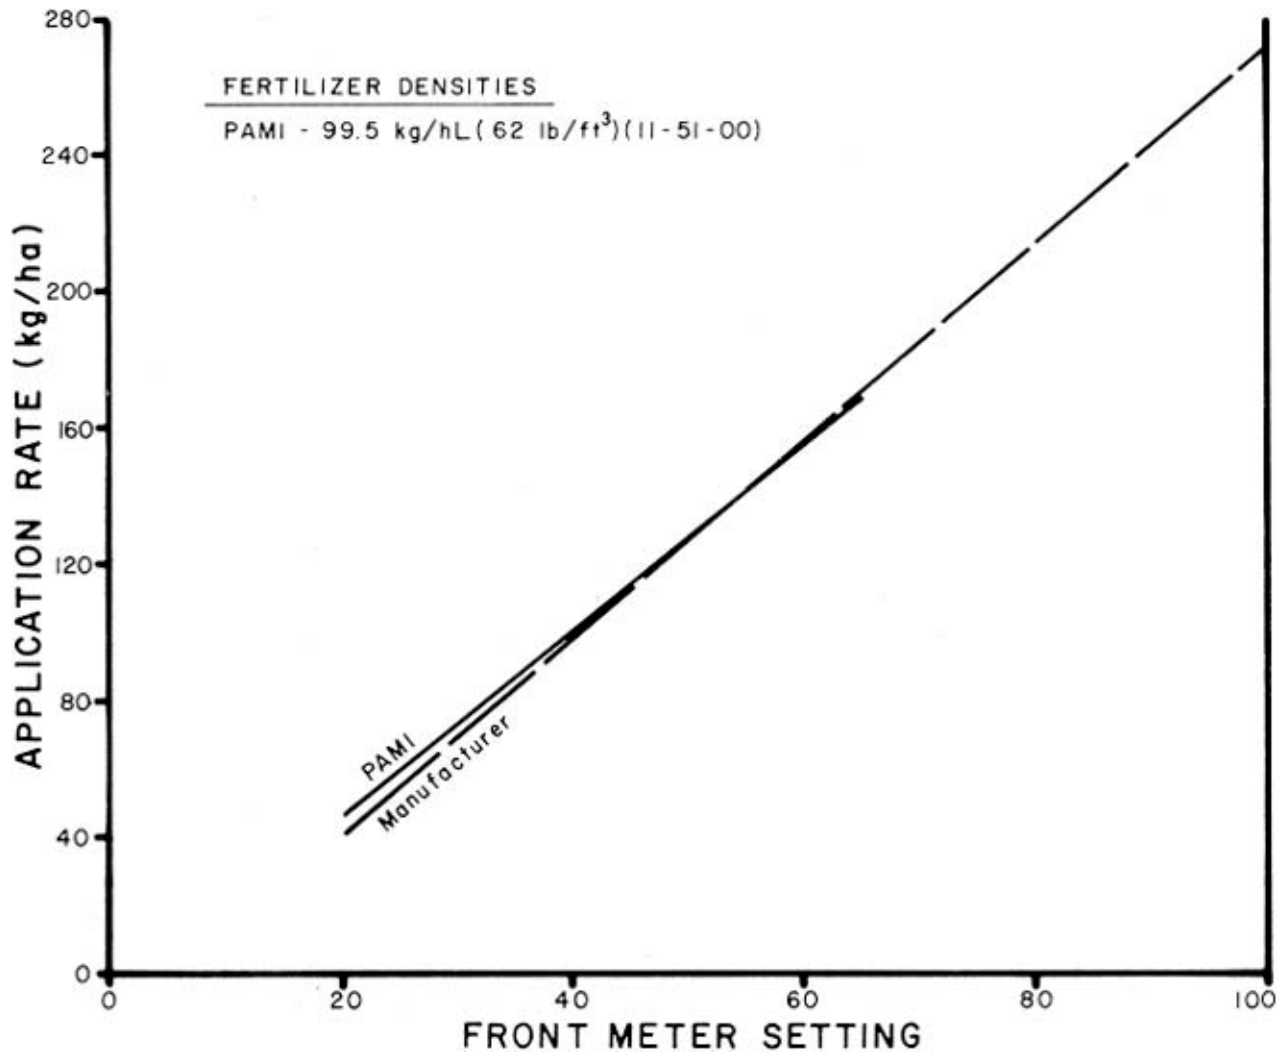
FIGURE 6. Metering Accuracy for the Front Meter in Fertilizer.

As is shown in FIGURE 6, the manufacturer's metering calibration for fertlizer, using the front meter, was accurate with little difference between measured and manufacturer's application rates.

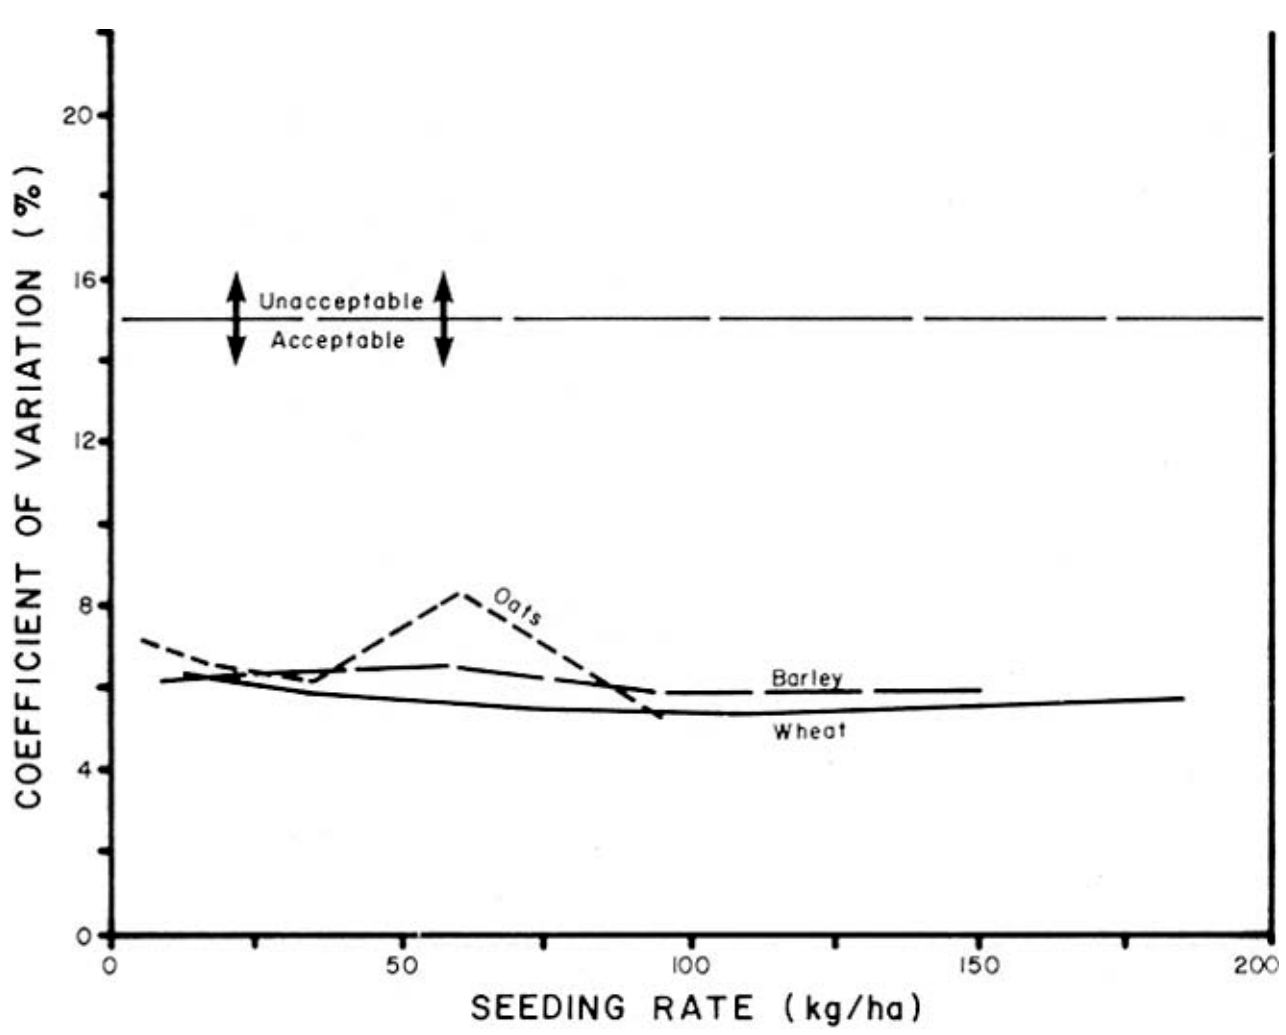
FIGURE 7. Seeding Uniformity in Cereal Grains at 9 km/h.

Distribution Uniformity: The pneumatic distribution system distributed seed uniformly from the metering system to the individual shank boots. FIGURE 7 gives seeding distribution uniformity for the Mords M-600 in wheat, barley and oats. Distribution was uniform over the full range of seeding rates. For example, at a seeding rate of 80 kg/ha (70 lb/ac) the coefficient of variation[2] (CV) was 5.5% in wheat, 6% in barley, and 6.5% in oats. Seeding distribution in rapeseed (FIGURE 8)

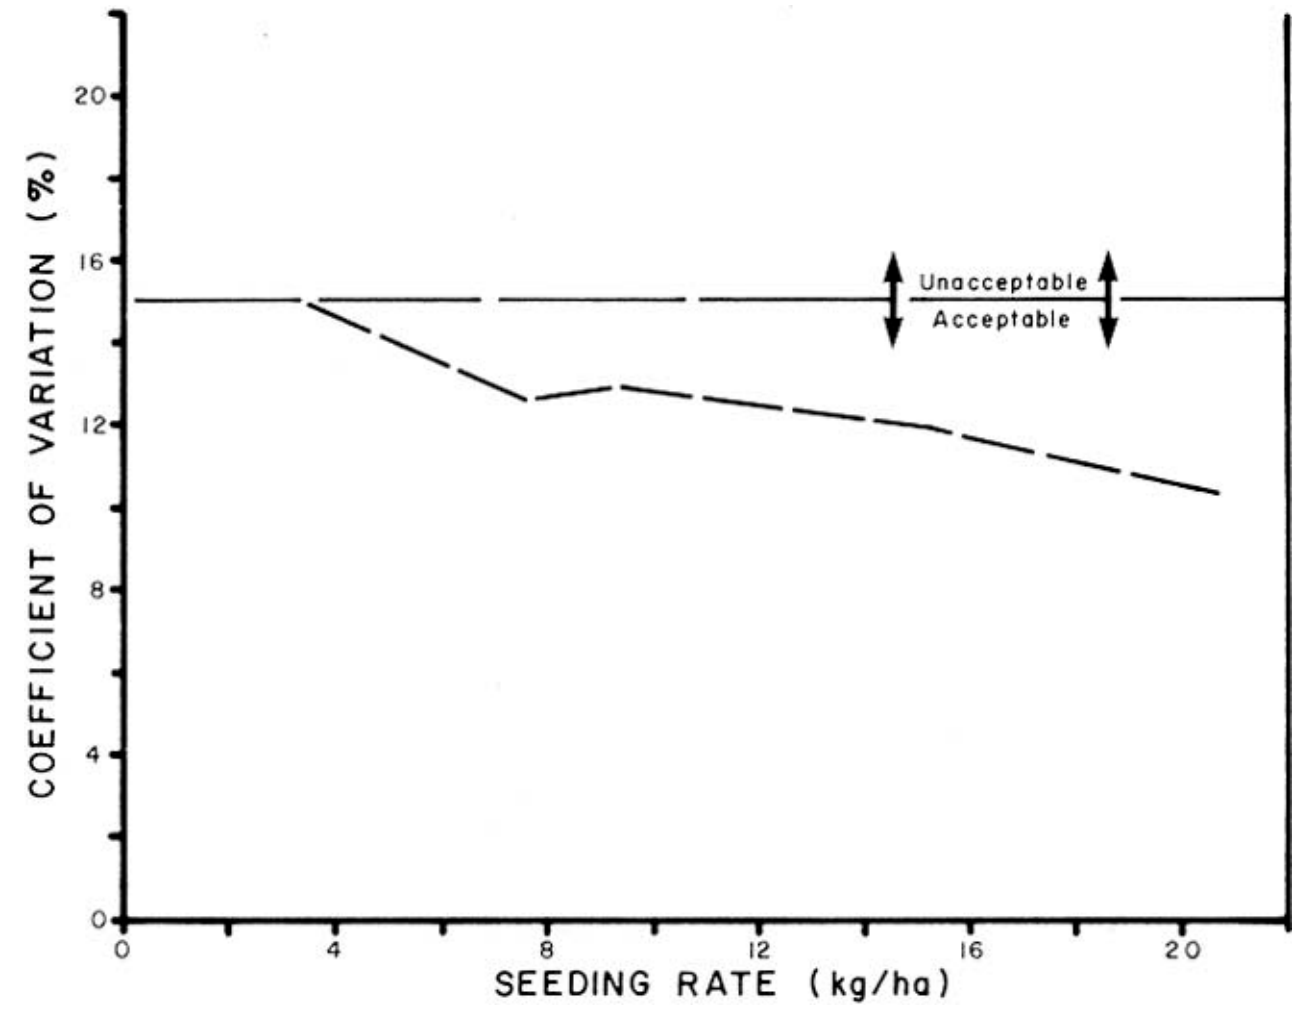
FIGURE 8. Seed Uniformity in Rapeseed at 9 km/h.

was also uniform with CV's ranging from 10 to 15% over the full seeding range. FIGURE 9 shows acceptable distribution uniformity in 11-51-00 fertilizer at rates up to 160 kg/ha (142 lb/ac). At higher rates, uniformity became unacceptable with CV's above 15%. All rates, shown in FIGURE 9, in excess of 172 kg/ha (153 lb/ac) were obtained using an alternate larger fan, supplied by the manufacturer at the end of the evaluation. It is recommended that the manufacturer consider modifications to the distribution system to improve distribution uniformity at high application rates in fertilizer.

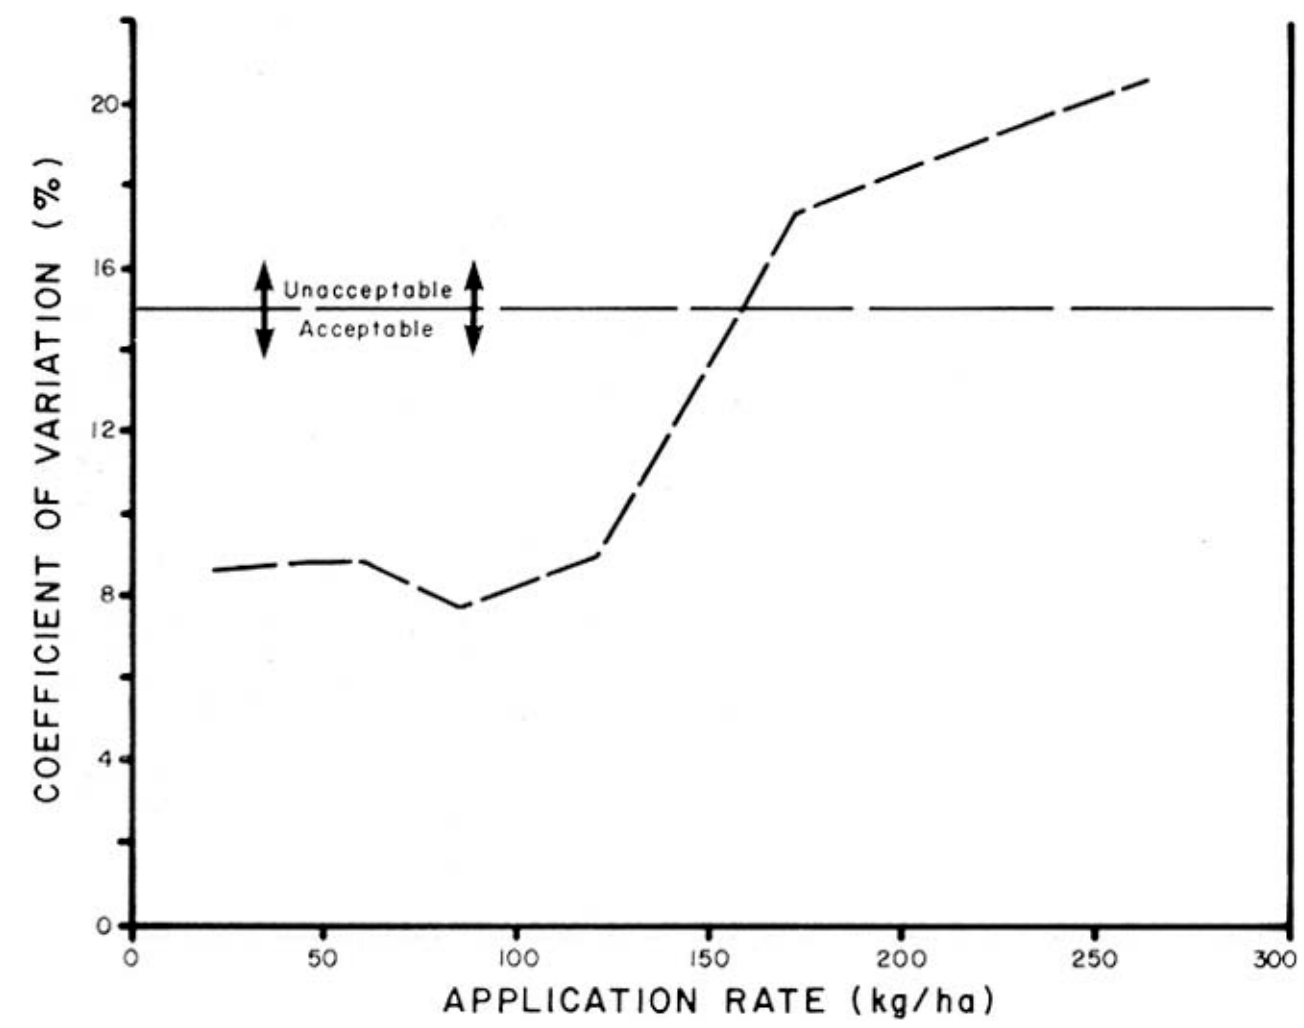
FIGURE 9. Distribution Uniformity in 11-51-00 Fertilizer at 9 km/h.

Distribution uniformity decreased at higher fertilizing rates due to the increased volume of seed being introduced into the constant volume of air supplied by the fan. Similarly, due to the air supply remaining constant regardless of forward speed or machine width, changes in distribution pattern uniformity could occur at different forward speeds or for different machine widths.

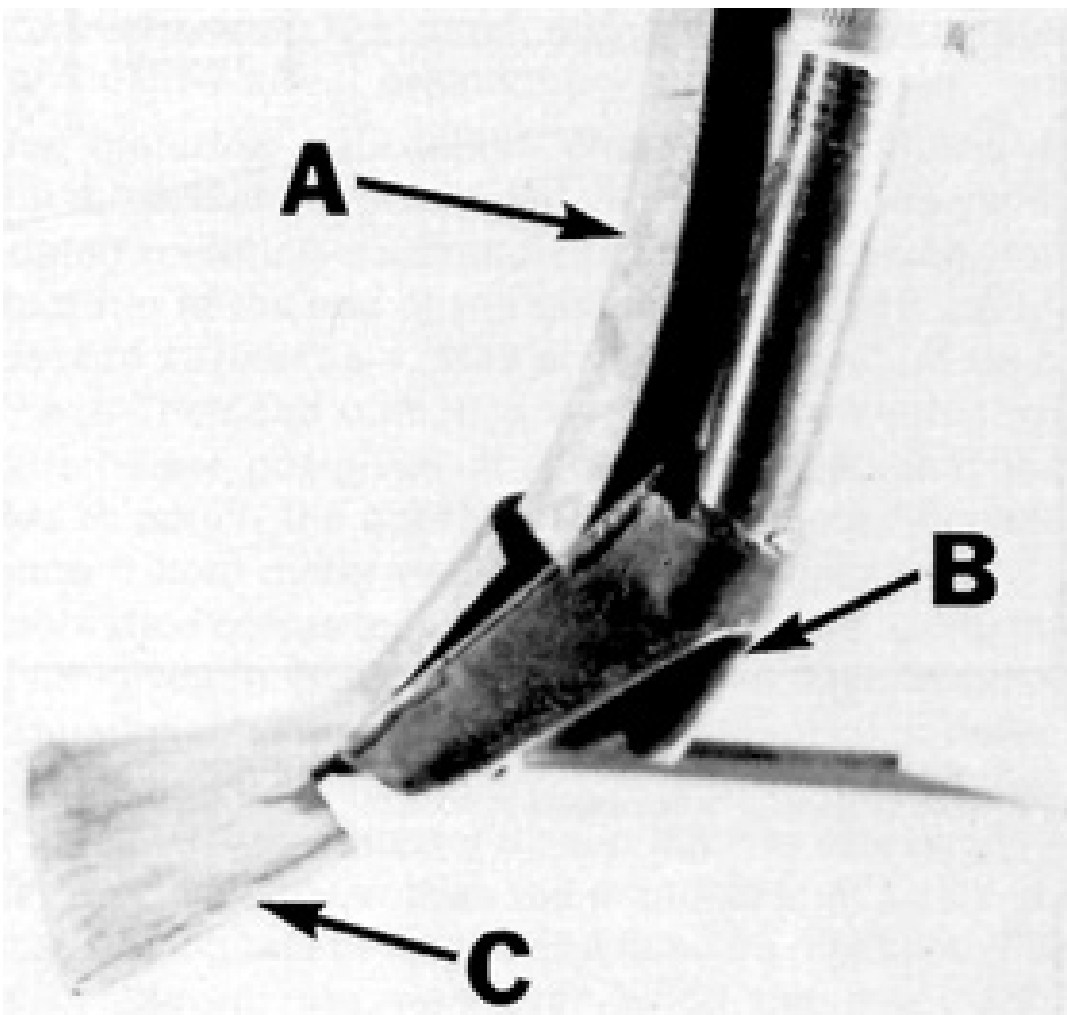
FIGURE 10. Morris Seed Boot: (A) Shank, (B) Seed Boot, (C) Sweep.

Seed Placement: Each seed boot consisted of a divider with two outlets (FIGURE 10) to spread the seed behind each cultivator sweep. However, the seed boot provided limited spreading behind each shank. In most fields it was possible to observe distinct rows ranging in band width from 85 to 135 mm (3.3 to 5.3 in) (FIGURE 11). With 305 mm (12 in) cultivator shank spacing, distances between rows varied from 170 mm (6.7 in) to 220 mm (8.7 in). This row spacing provided adequate windrow support providing light crops were laid across the rows rather than parallel to them.

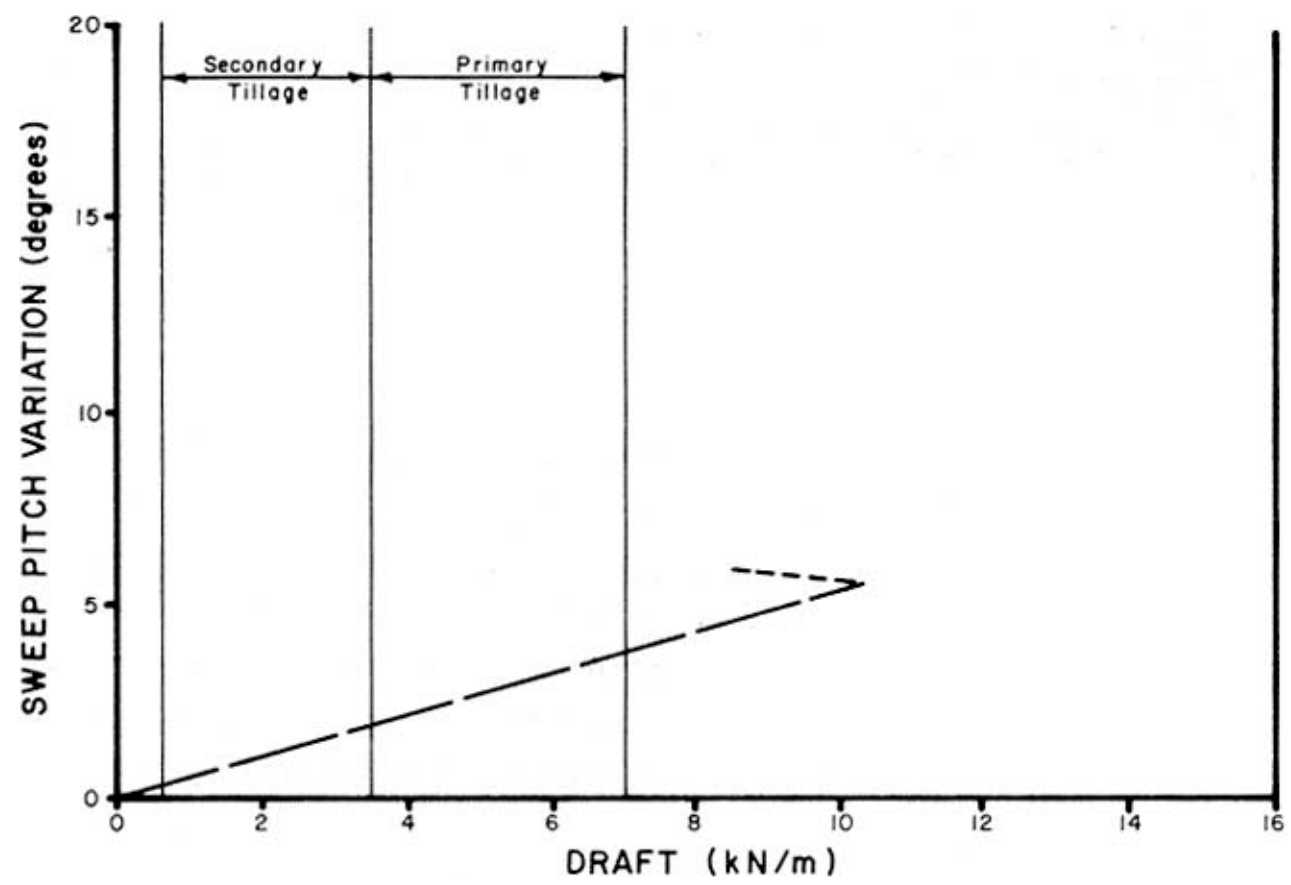
FIGURE 13. Sweep Pitch Variation over Normal Range of Draft (305 mm Shank Spacing).

43 degree stem angles, giving a no-load sweep pitch of 4 degrees. These shanks were suitable for seeding since sweep pitch (FIGURE 13) varied only 4 degrees over the full range of draft normally expected for a heavy duty cultivator. This resulted in uniform tillage depth and a smooth furrow bottom over a wide range of soil conditions.

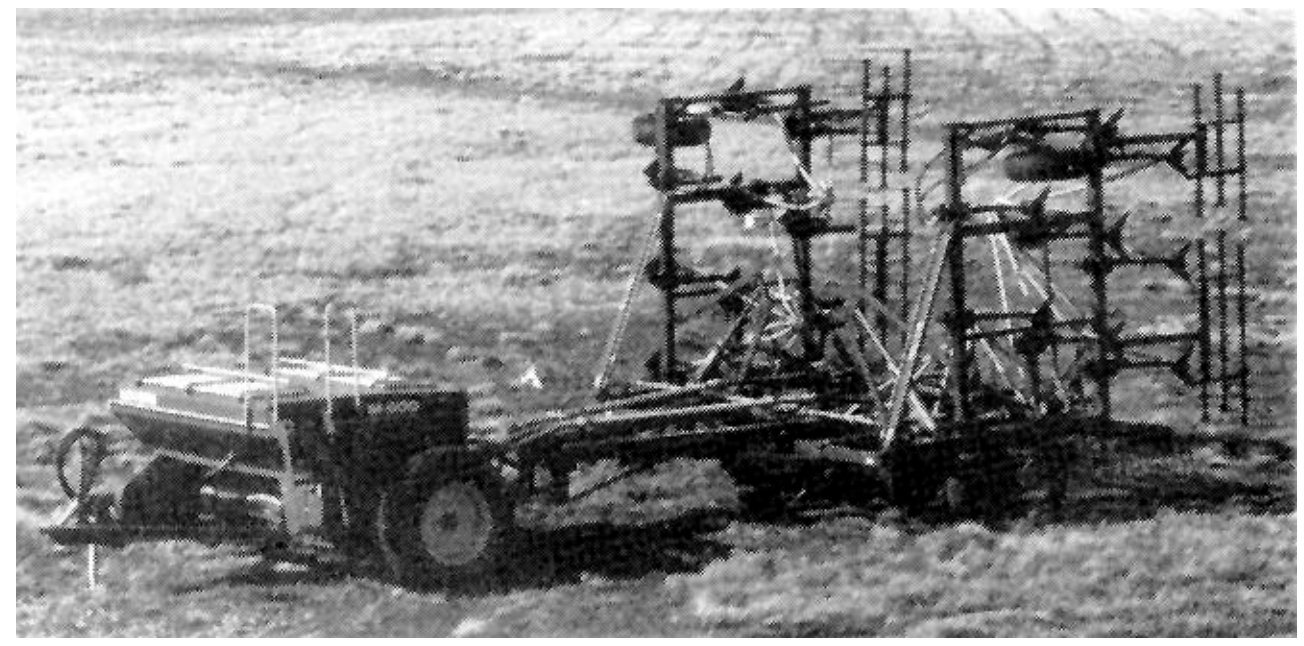
FIGURE 15. Transport Position.

Transporting: A distinct advantage of cultivator mounted pneumatic seeders over conventional drills, is the ease with which relatively wide machines can be transported. The Morris applicator-cultivator assembly was easily placed in transport position (FIGURE 15) in less than five minutes. Two hydraulic cylinders raised the cultivator wings to the upright position. The metering system was conveniently engaged and disengaged with an electrically operated lockout, controlled from the tractor seat. For long distance travel or travel at high speeds, the meter drive chain should be removed. This procedure was somewhat inconvenient due to poor access to the drive chain behind the meter drive chain safety shield. For short transport distances at slow speeds, the chain could be left on and the electrically controlled meter drive clutch disengaged.

The assembly towed well in transport position. Overall transport height and width were 3.9 m (12.8 ft) and 5.9 m (19.4 ft) respectively, requiring care when transporting on public roads.

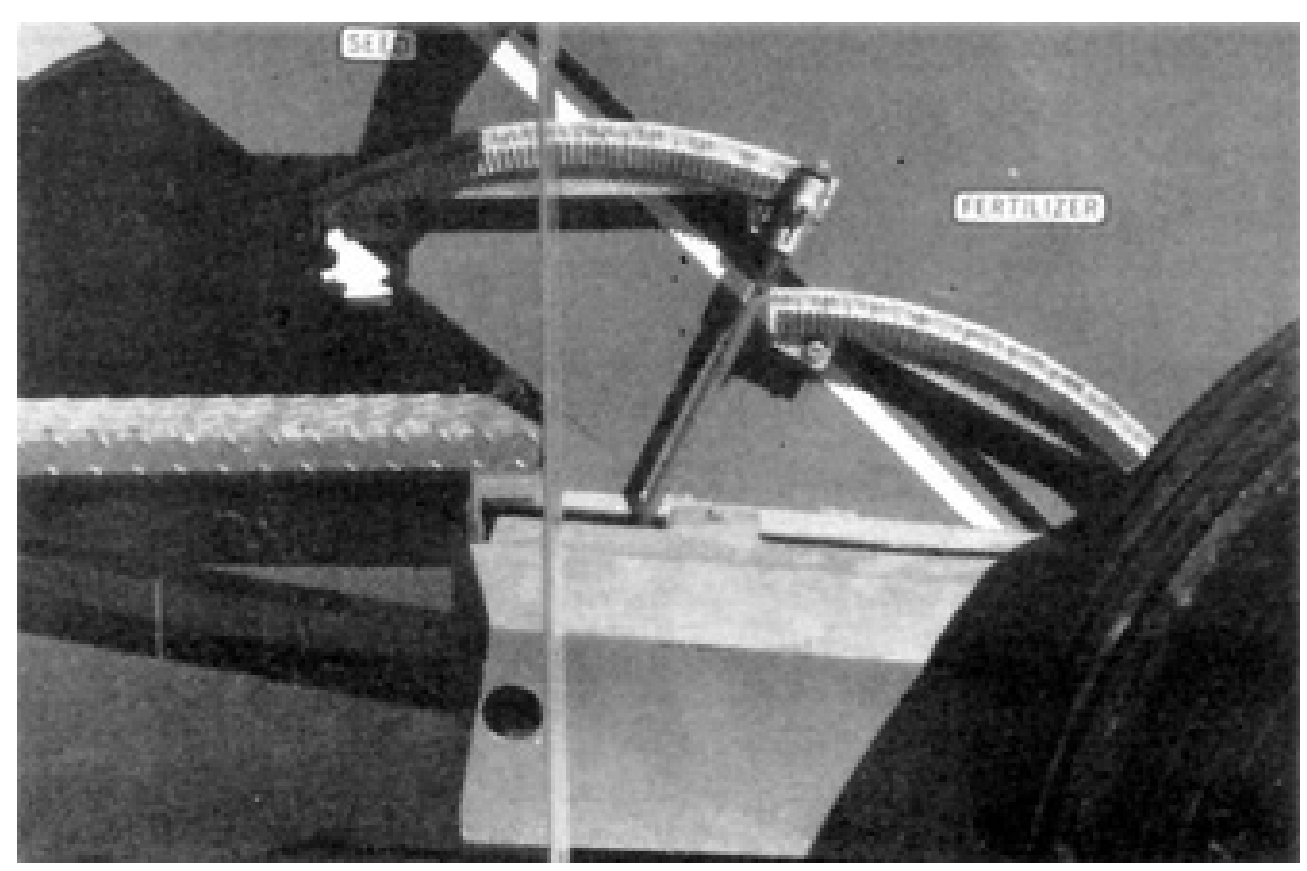
FIGURE 16. Application Rate Adjustment.

Application Rate: Application rate was changed by adjusting the variable speed drive for seed and fertilizer as shown in FIGURE 16. The meter scale was adjustable from 0 to 100 in increments of one. The calibration charts in the operator's manual were not accurate for wheat and barley and no calibration was included for rapeseed. Improved calibrations for wheat and barley and a calibration for rapeseed, in both pounds per acre and kilograms per hectare, were supplied by the manufacturer at the end of the test.

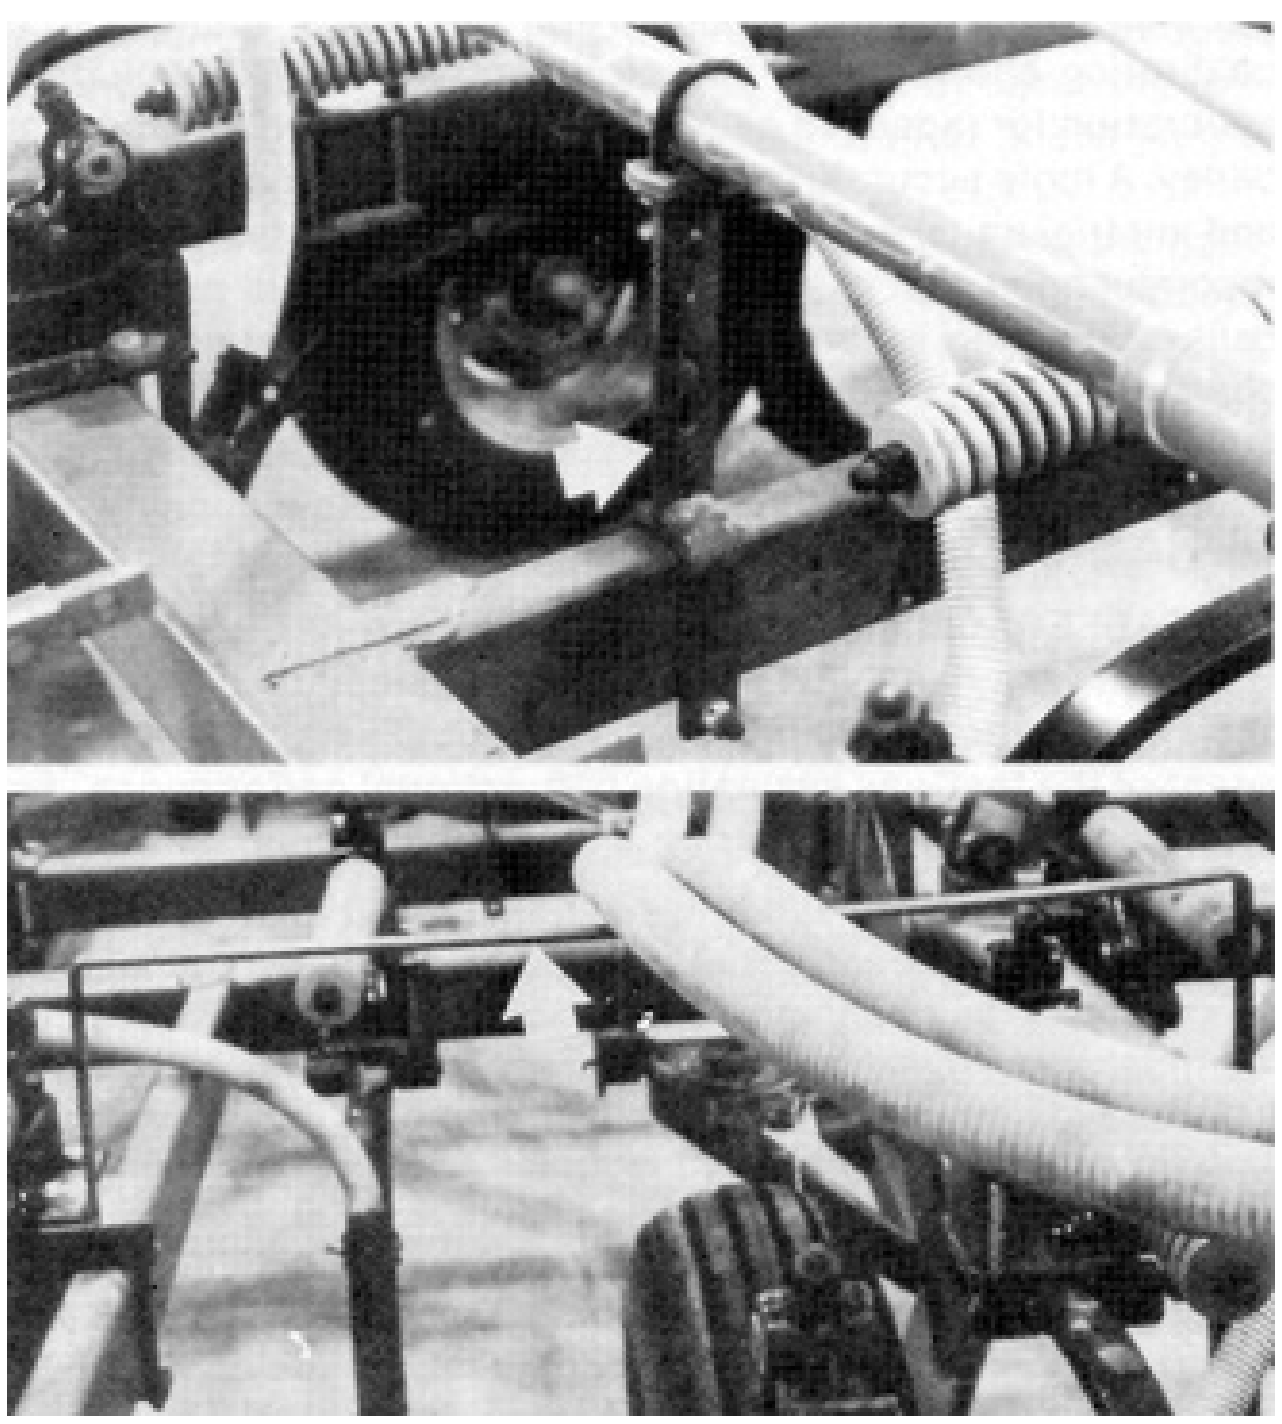
FIGURE 17. Fabricated Support Brackets.

Support Brackets: Brackets were fabricated to support the primary distribution tubes on the cultivator and to prevent tube interference with the cultivator wheels (FIGURE 17) at the beginning of the test. It is recommended that some means of supporting the primary distribution tubes on the cultivator be supplied as standard equipment.
